The Riparian Forests of the Sacramento River Ecosystem

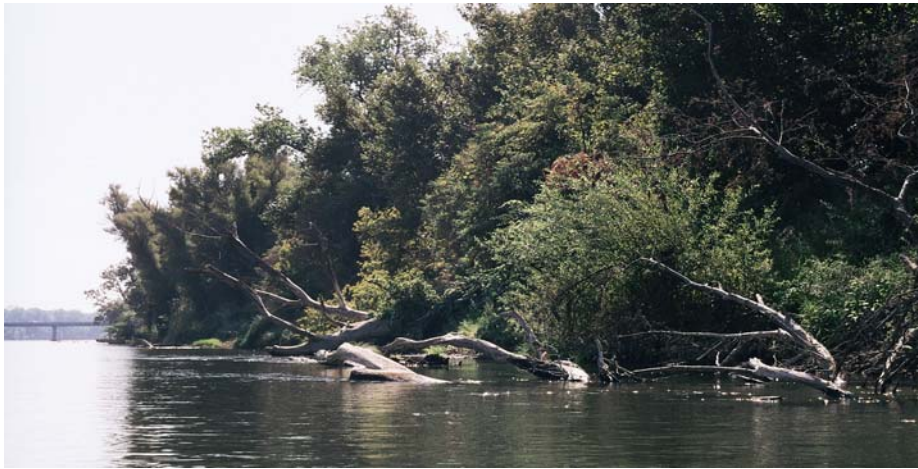
Shaded banks are an important component of the Sacramento River ecosystem, created as the river erodes into a bank supporting riparian forests (Figure 2-10). This habitat has an important aquatic component. The U.S. Fish and Wildlife Service has dubbed this type of area "shaded riverine aquatic cover," (known as SRA) an area where "the adjacent bank is composed of natural, eroding substrates supporting riparian vegetation that overhangs or protrudes into the water" (USFWS, 1992). It is also characterized by "variable amounts of woody debris, such as leaves, logs, branches and roots, as well as variable depths, velocities and currents." SRA provides feeding and cover for aquatic species such as salmon, and when less vegetated (see following section on cut banks) provides burrowing substrate for bank swallows.

Figure 2-10. *Shaded Riverine Aquatic Habitat along the Sacramento River.*

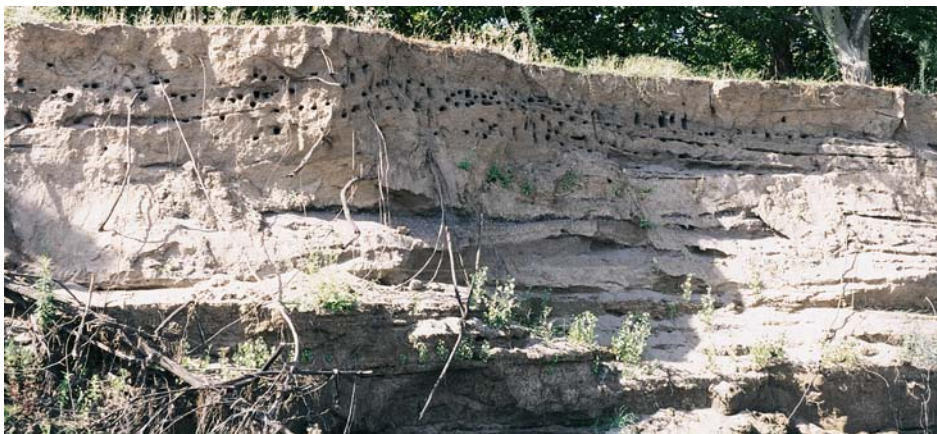
Figure 2-11. *Cut bank with bank swallow burrows, Sacramento River, Chico Landing-Red Bluff Reach*
